Inspection Report

Northville, MI 48168

Inspection Date April 13, 2016
Client [REDACTED]
Inspector Apollo Zimmerman
734-858-8491

A-Z MICHIGAN
HOME INSPECTION

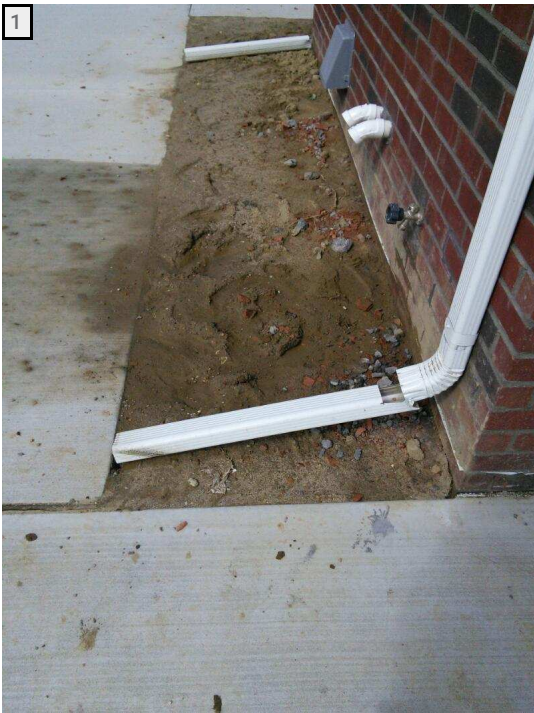
✓ Extension discharges to an obstacle

Location	Exterior: Ground View
Impact	The obstacle prevents rain water from discharging away from the foundation increasing the risk of moisture intrusion
Suggested Action	Replace the extension to be away from the obstacle

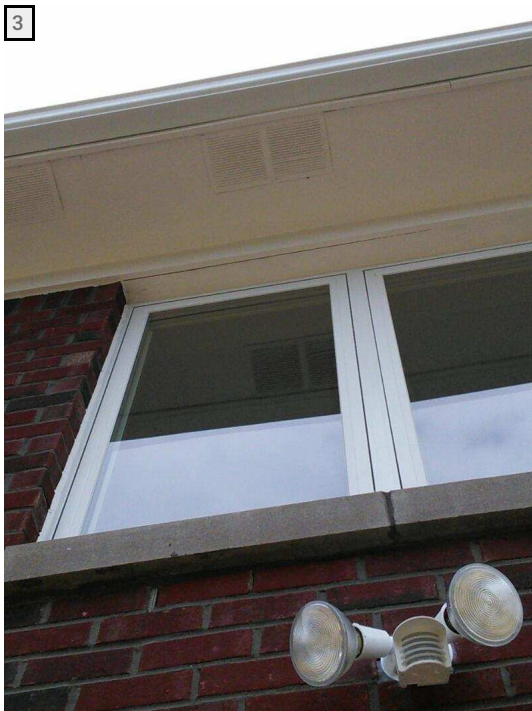
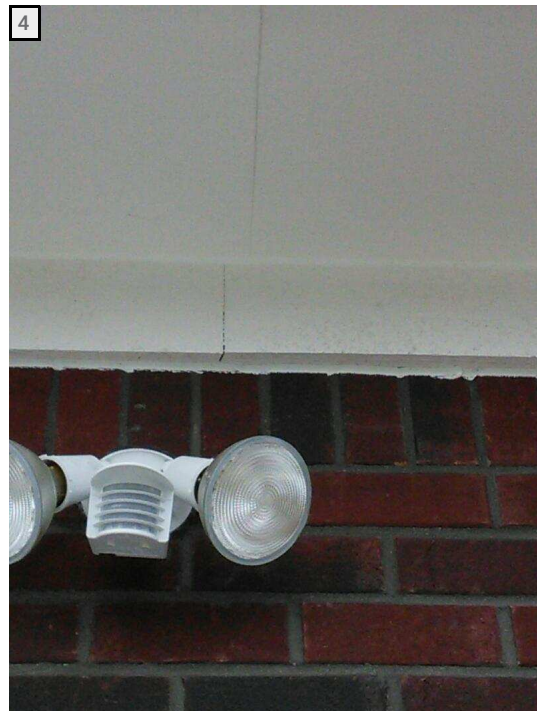
✓ Caulk has holes or gaps

Location	Exterior: Ground View
Impact	The gaps could allow for moisture and insect intrusion which may cause cause damage to the wood over time
Suggested Action	Repair the caulking

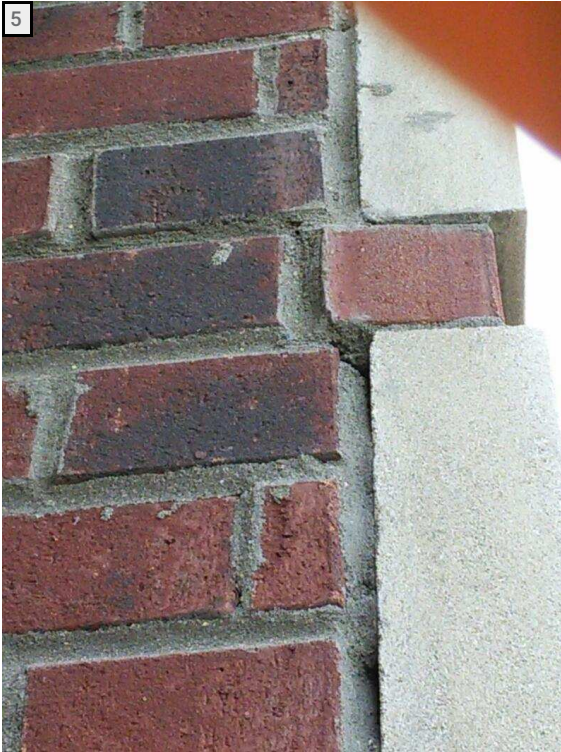
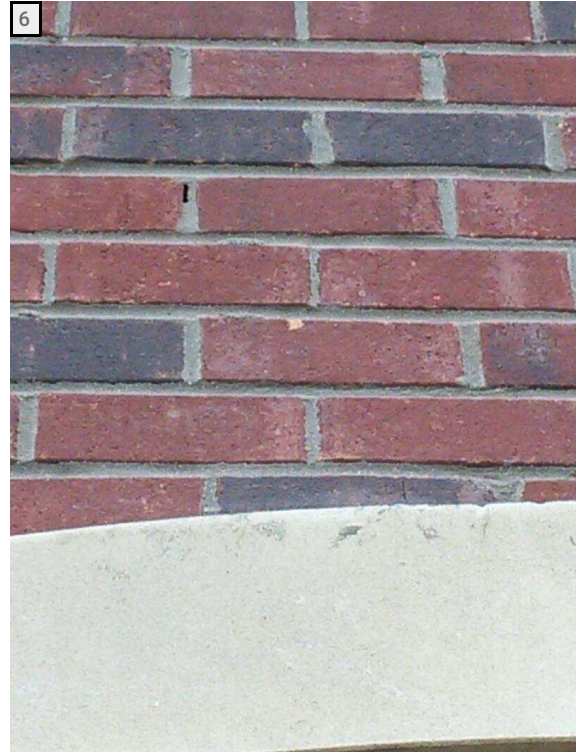
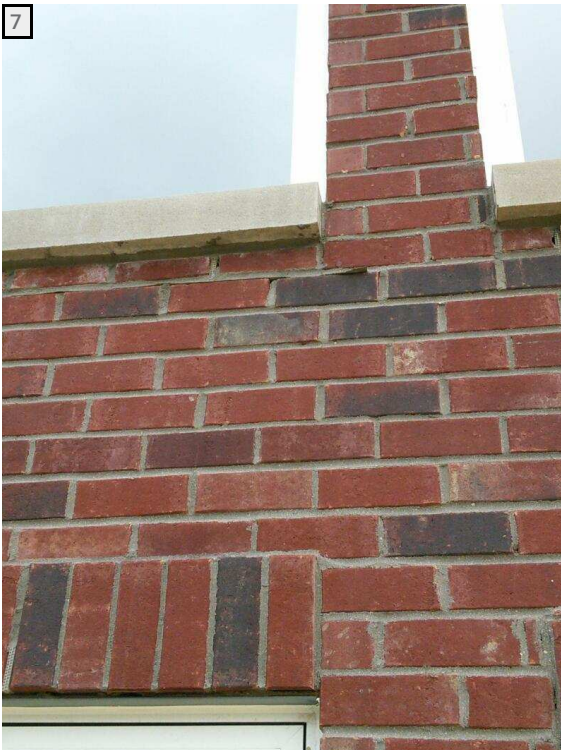
✓ Mortar missing/deteriorated

Location Exterior: Ground View
Impact Possible moisture or pest entry

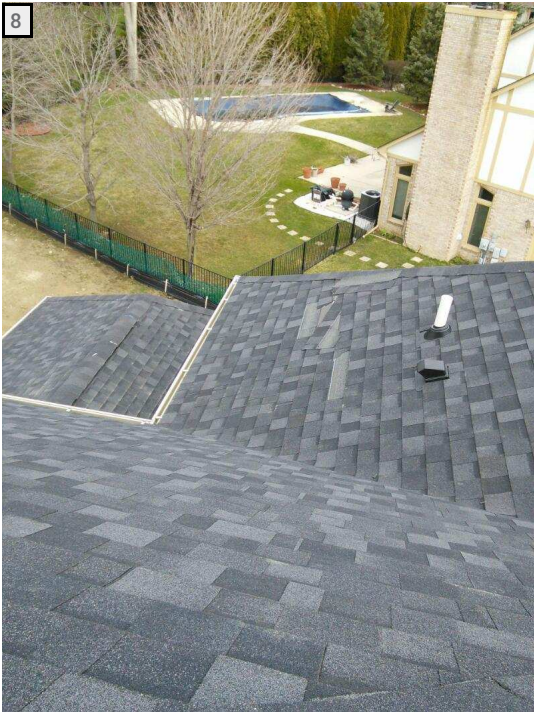
⬇ Missing

Location	Exterior: Roof View
Impact	Without roof covering, the underlying sheathing is highly likely to become damaged
Suggested Action	Replace the missing roof material

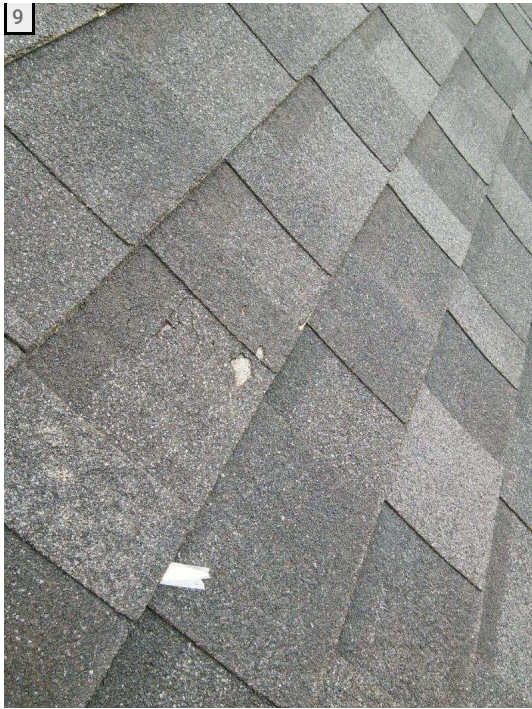
⊖ Damaged in isolated areas

Location	Exterior: Roof View
Impact	The damaged areas may expose the underlying sheathing to potential water damage
Suggested Action	Replace the roof material in the damaged areas

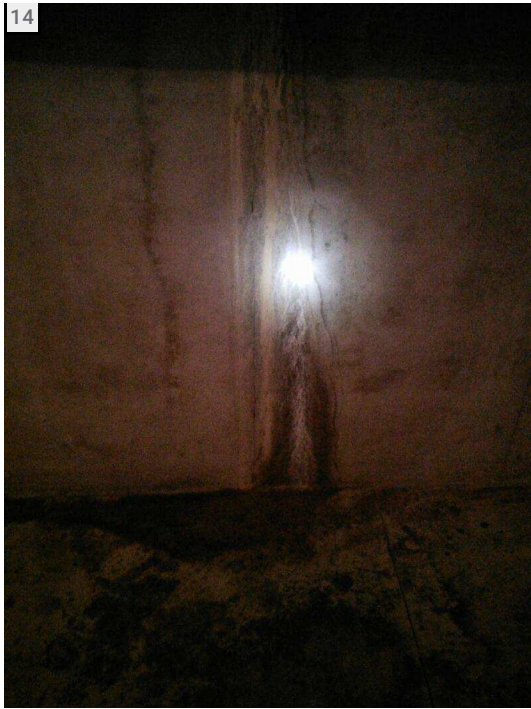
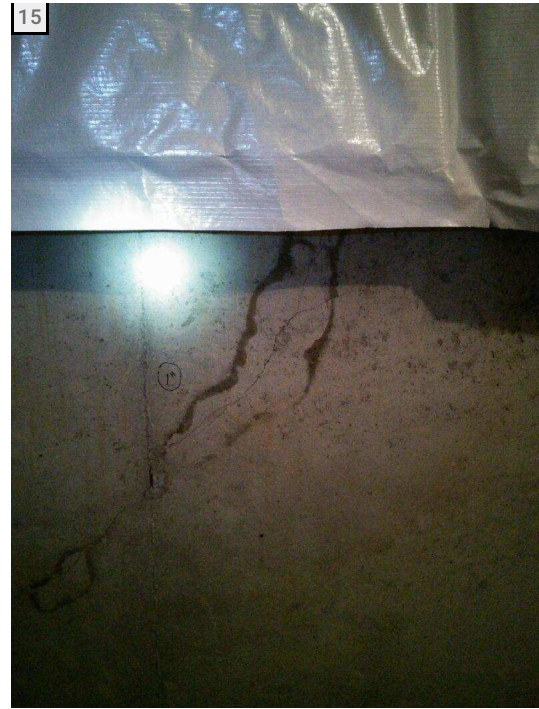
⊖ Exhibits vertical cracking with evidence of moisture intrusion

Location	Basement
Impact	The moisture leaks may cause damage to basement finishings
Suggested Action	Have epoxy injected into the crack by a licensed waterproofing contractor

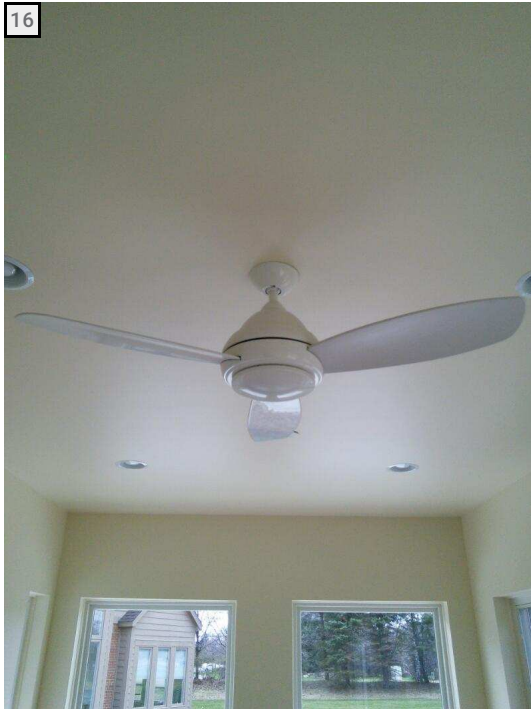
✓ Does not light

Location Family Room

Impact If intended to light as others in home address.

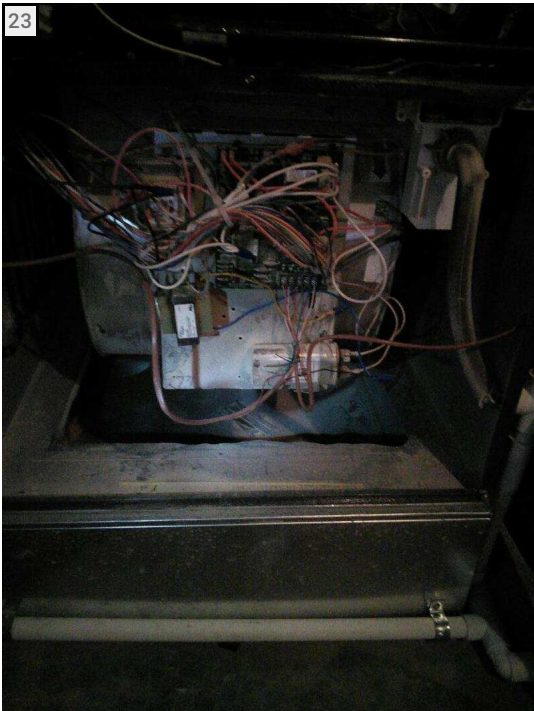
⊖ In need of cleaning

Location	Basement
Impact	A dirty furnace runs less efficiently
Suggested Action	Have the furnace cleaned and serviced by an HVAC service professional. Put the furnace on an annual maintenance program to ensure long term safe and optimal operation

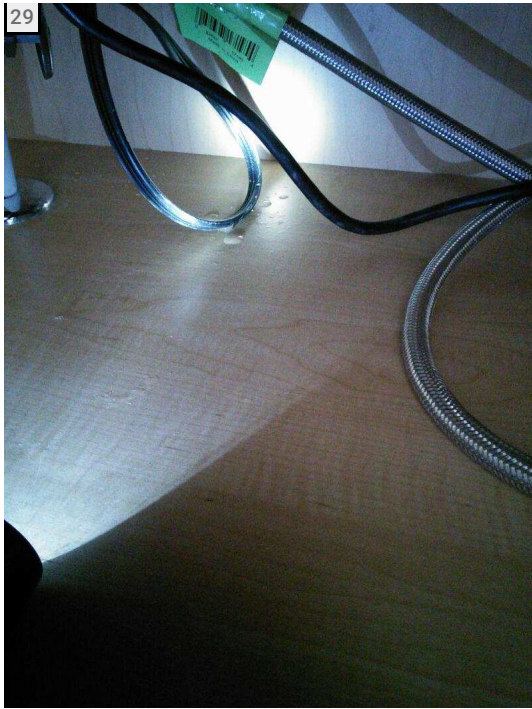
– Faucet is leaking

Location	Kitchen
Impact	The leak may become a nuisance. If not repaired, calcium deposits may form at the base of the valve and water may begin to leak into the vanity
Suggested Action	Repair the handle valve or replace the entire faucet assembly

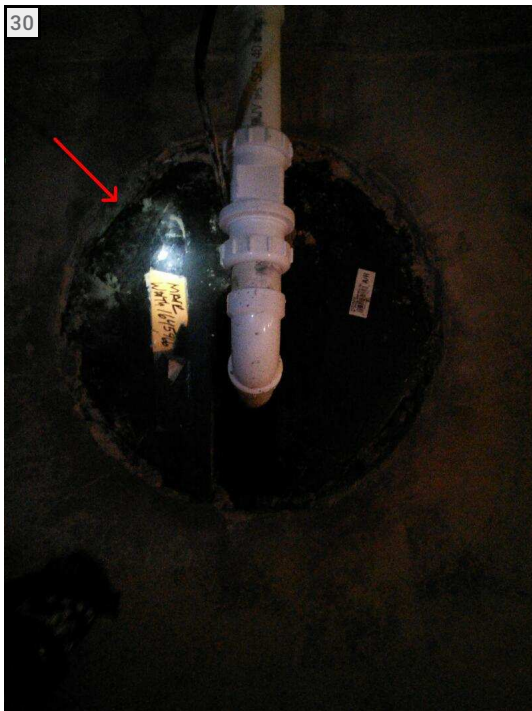
✓ Reference

Location Basement

Cement covering lid. Unable to remove to test pump. Have cement chiseled away.

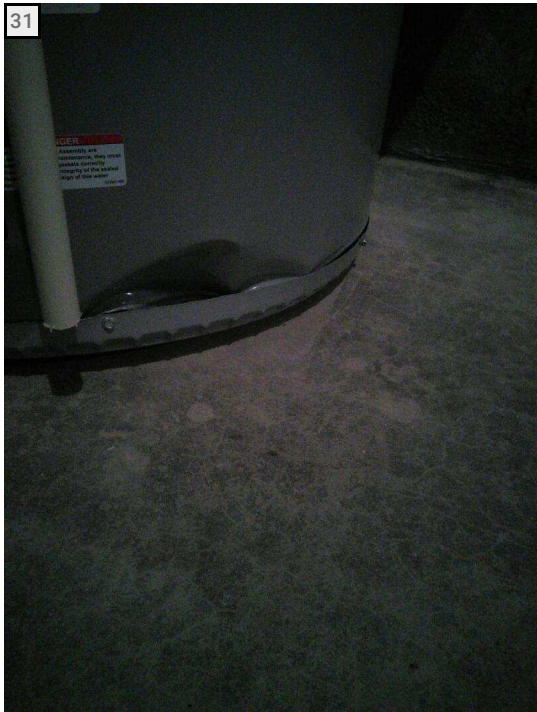
Casing damaged

Location	Basement
Impact	May be sign of dropped unit. Possible internal damage.
Suggested Action	Inquire or have replaced with non damaged.

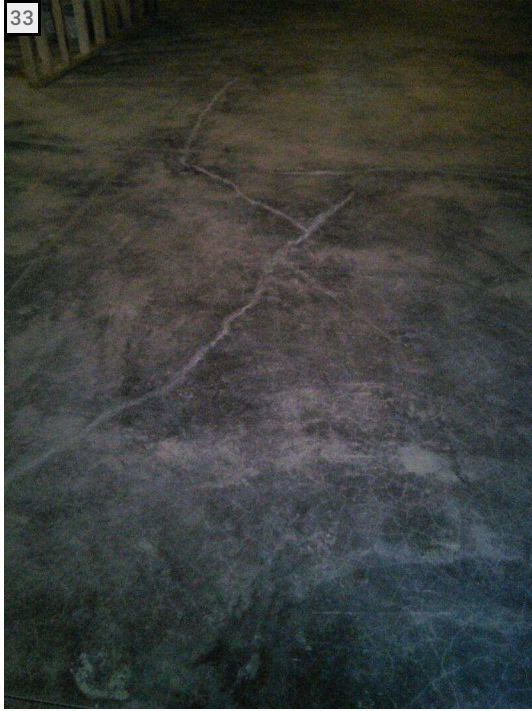
✓ **Cracking with no evidence of moisture intrusion**

Location	Basement
Impact	The cracking may allow for moisture intrusion
Suggested Action	Monitor for evidence of moisture intrusion or heaving. Should any moisture appear, recommend evaluation for repair by a licensed waterproofing contractor. Should heaving occur, recommend evaluation by a structural engineer.

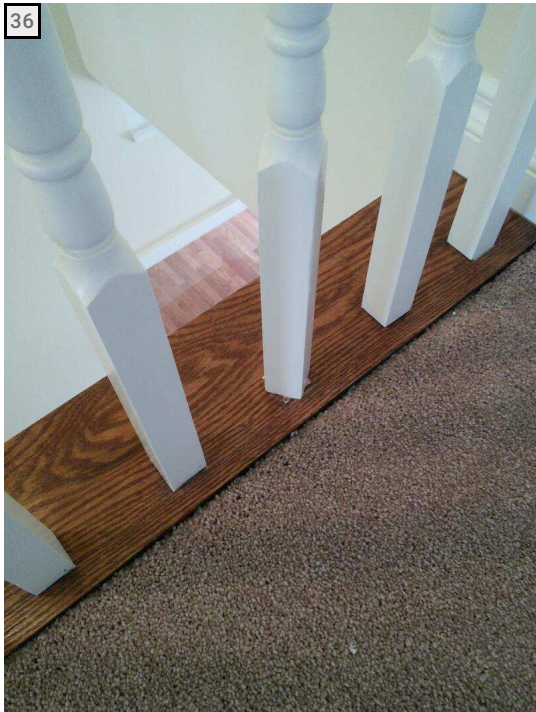
✓ **Ballusters are loose**

Location	Hallway and Stairs
Impact	The ballusters could further loosen and eventually fall out
Suggested Action	Remove, resecure and reinstall the ballusters

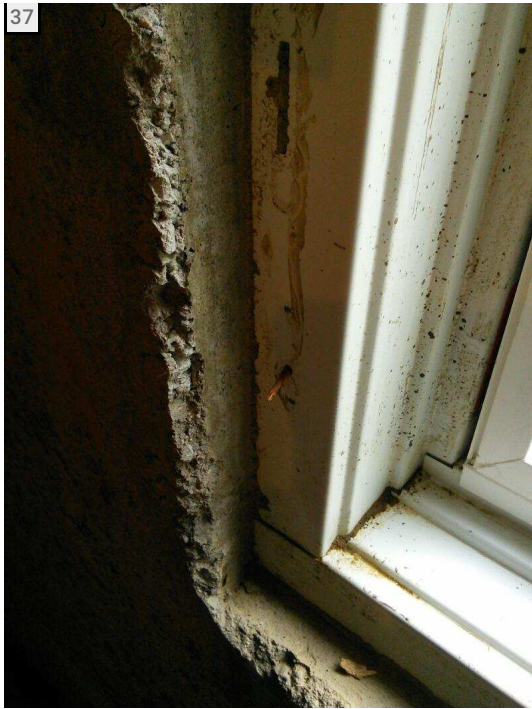
⚠ **Exposed nails**

Location	Basement
----------	----------

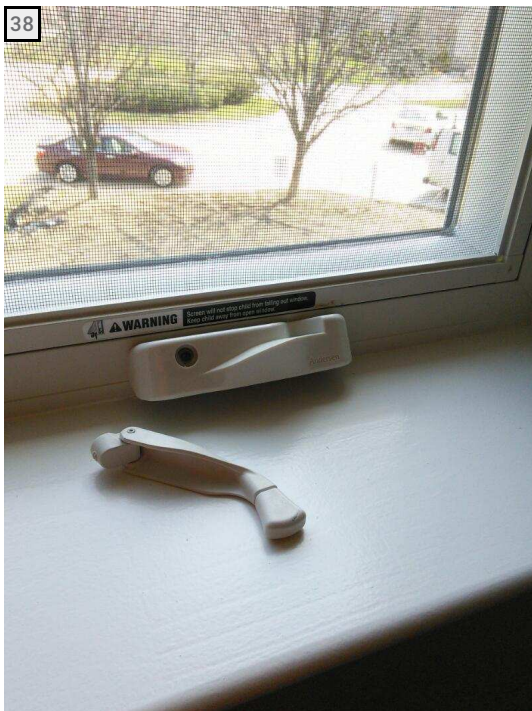
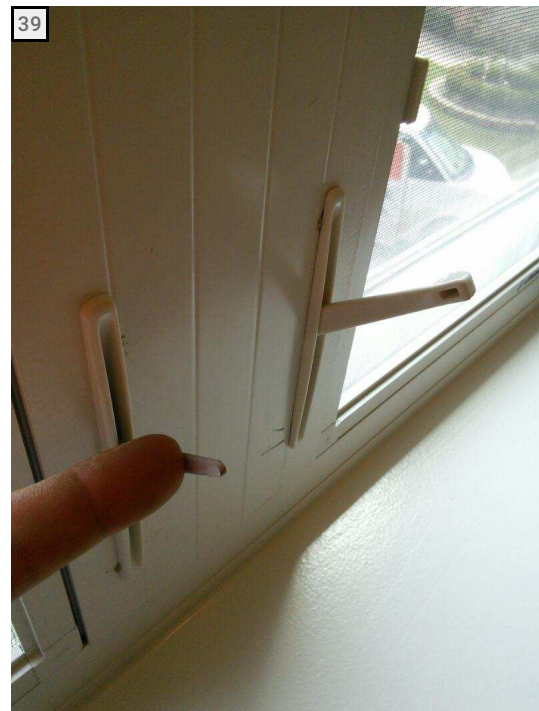
⊖ Hardware is missing or broken

Location	1st Bedroom, 3rd Bedroom
Impact	With insufficient hardware, it is difficult to open the window
Suggested Action	Replace the hardware

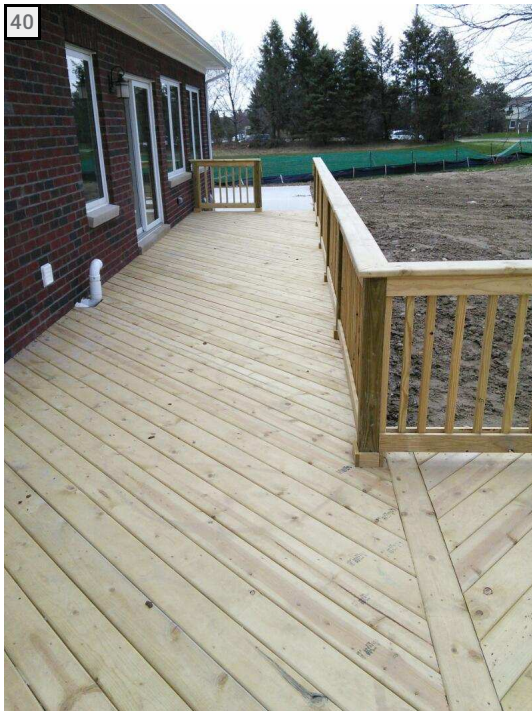
– Not currently stained or weatherproofed.

Location	Exterior: Ground View
Impact	Leaved unsealed will shorten the life of the deck.
Suggested Action	Restain and/or reseal with a weather resistant sealer

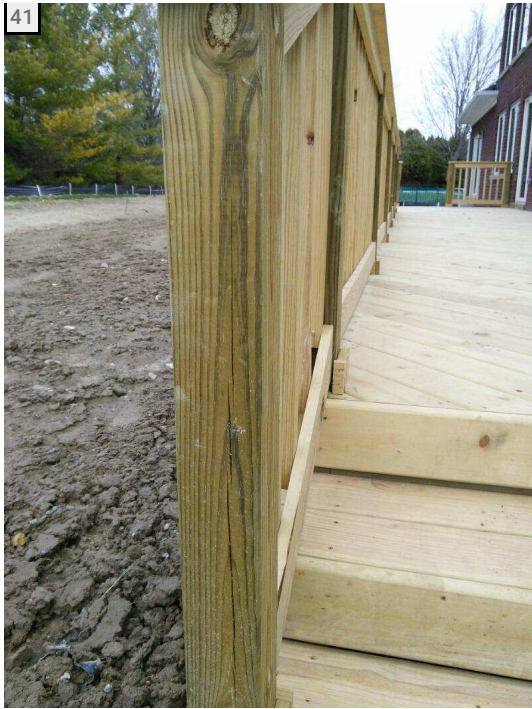
– Splitting wood

Location	Exterior: Ground View
Impact	In time will worsen.
Suggested Action	Replace

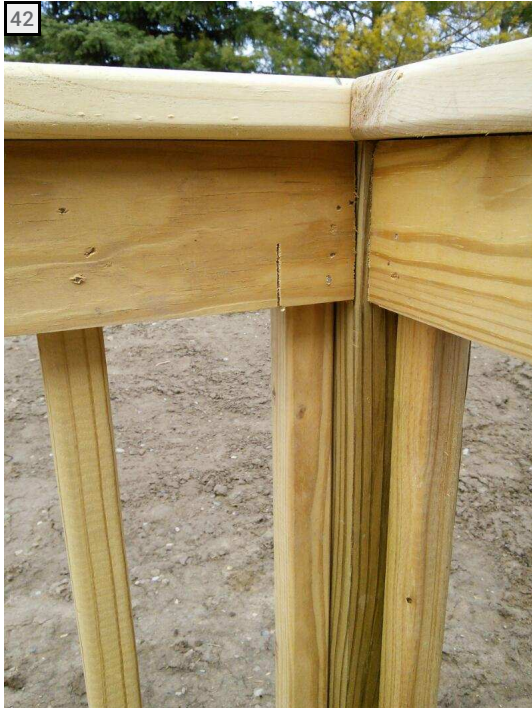
✓ **Damaged**

Location Exterior: Ground View
